# Solving NLPCB Impediments to Decommissioning

Energy, Utility & Environment Conference  
San Diego, California  
25 February 2019

Stephen Mitchell, PG  
Senior Vice President  
Weston Solutions, Inc.

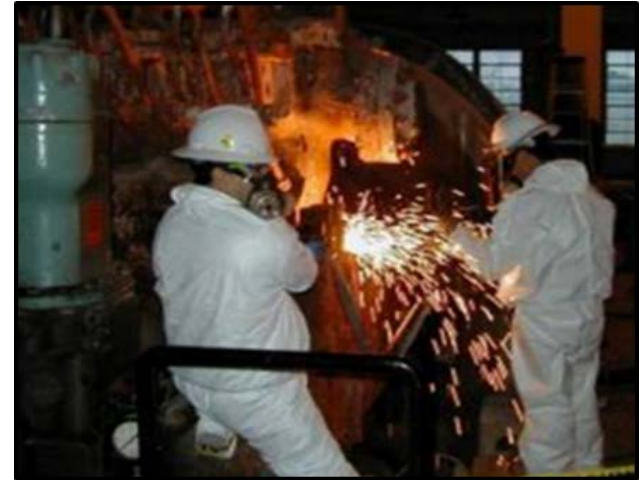
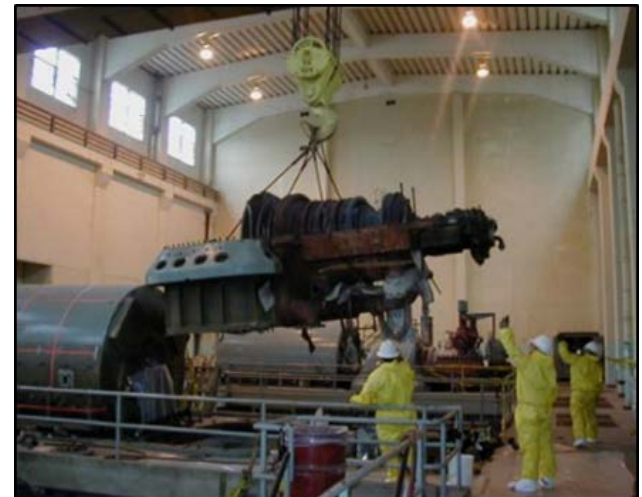
## Avoid Surprises That Derail Projects

- **Project:** Contractor selected for demolition based on investment recovery, payment on demo cost vs. asset value recovery.
- **Issue:** Contractor assumed painted steel unregulated for salvage, but PCBs found to be widespread on painted infrastructure and equipment. Bid specs vague and work stopped for EPA guidance, resulting in schedule/cost impact, salvage value loss.
- **Result:** Contract dispute / litigation, with consultant later pulled in to help sort it out.

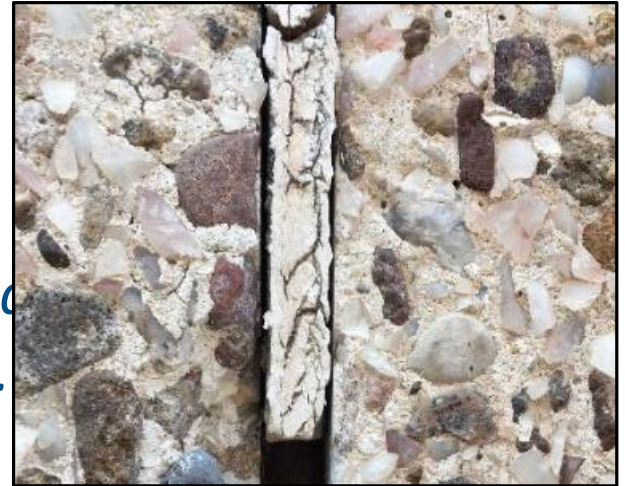
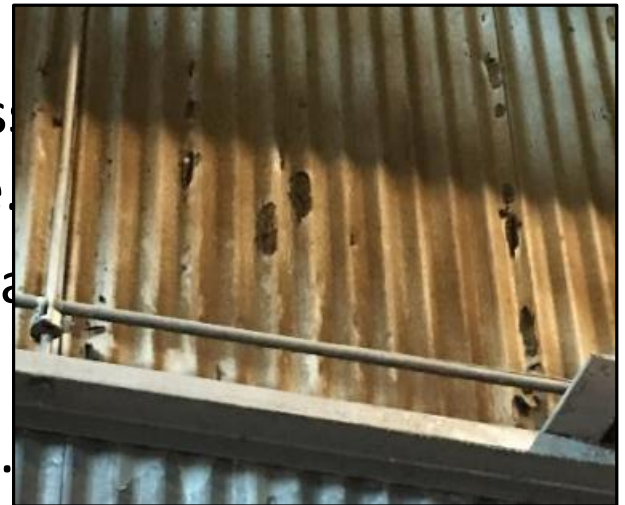
## Consider Non-Liquid PCB Materials

- PCBs intentionally incorporated into solid materials that are not the result of a spill.
- *NLPCB building products may include dried paint, caulk, adhesives, mastic, Galbestos.*
- PCB concentrations 10% - 20% by weight
- Continued use is not authorized.
- No proactive testing requirement to assess status while in use nor a removal timeline.
- No removal standard except paint on metal
- Characterize when demo certain because materials regulated for disposal  $\geq 50$  ppm.

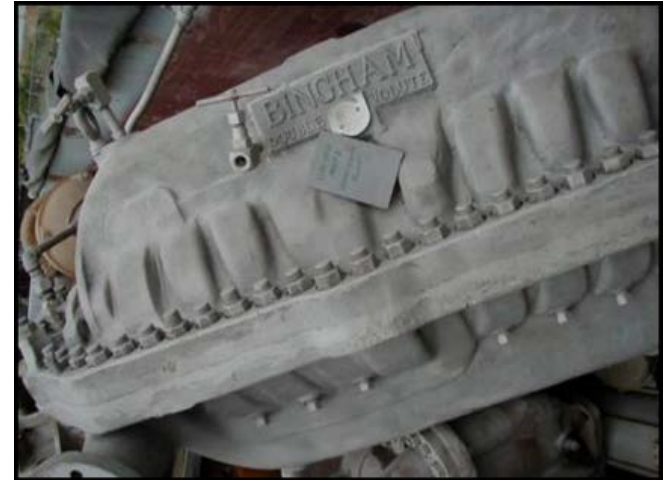
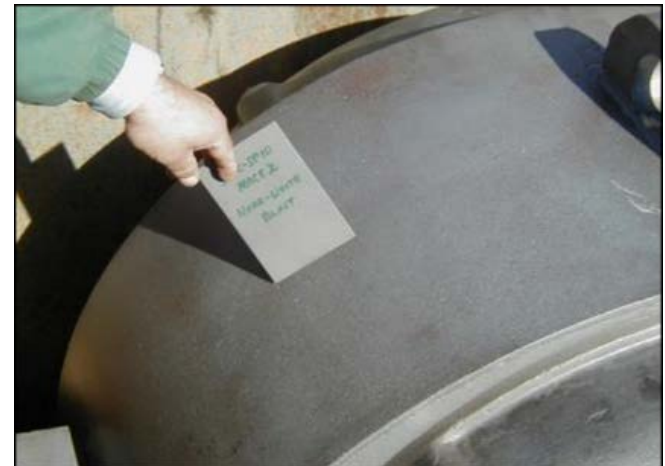
## Example 1: Paint On Equipment

- **Project:** 1940s gas power plant undergoing selective dismantlement for adaptive reuse
- **Issue:** PCB >50 found in paint on non-PCB equipment for salvage with nearby PCB oil mishandling and spills known.
- **Solution:** Decontaminated paint from the equipment per 761.79 NACE Standard 2 white blast finish with visual inspection. Disposed of paint and grit blast waste as TSCA waste with spill history uncertain. Approach allowed 740 tons of equipment to be salvaged/reused instead of more expensive TSCA landfilling (50% savings).

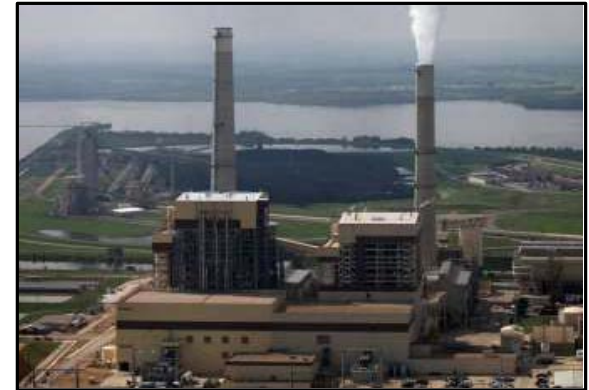
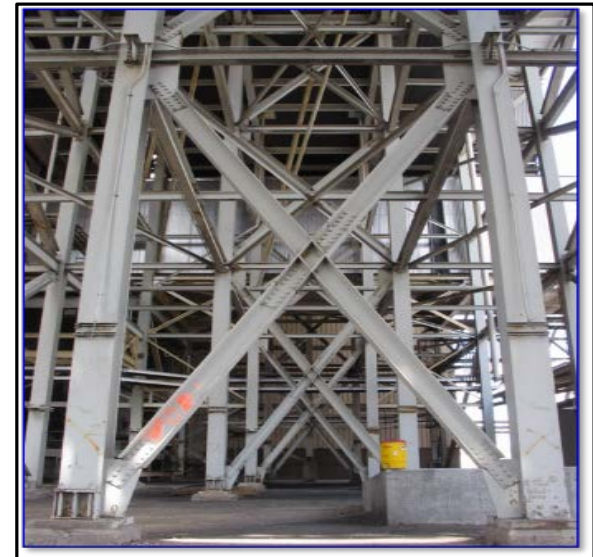
## Example 2: Paint on Infrastructure

- **Project:** 1960s coal-fired power plant undergoing refit for air pollution controls
- **Issue:** Nine-story tall electrostatic precipitator demolition halted when client due diligence found PCB <50 ppm on painted steel, with past spills from nearby transformer fires suspected, impeding contractor's steel salvage plans.
- **Solution:** Assessed paint to differentiate PCBs from spills vs manufacture. Since PCB in paint < 50 ppm found structure wide, EPA concurred PCB < 50 ppm in paint was "excluded PCB product" not from spill. Demolition moved forward without TSCA disposal requirements.

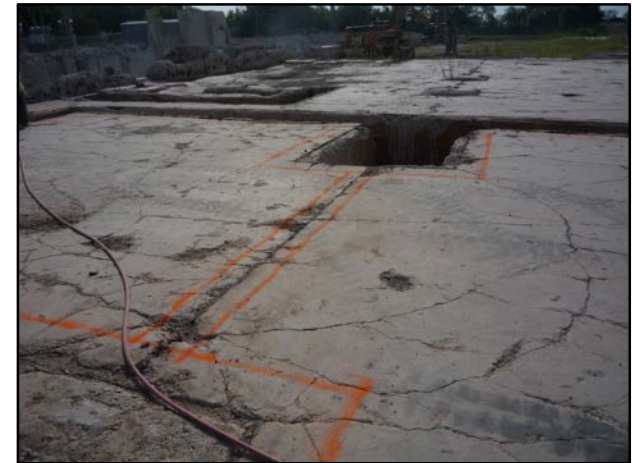
## Example 3: Caulk in Foundation Joints

- **Project:** 1950s gas-fired plant undergoing complete demolition for reuse as parkland
- **Issue:** PCBs > 10,000 ppm in caulk in plant foundation joints contaminated adjacent concrete and impeded in place closure.
- **Solution:** Saw cut out caulk and adjacent PCB-affected concrete for disposal as bulk product waste per 761.62(a) as no PCB spills in the area were known. Remaining unaffected concrete closed in place onsite.

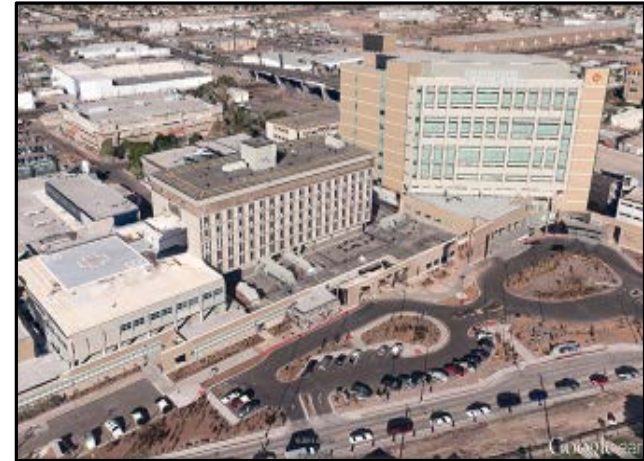
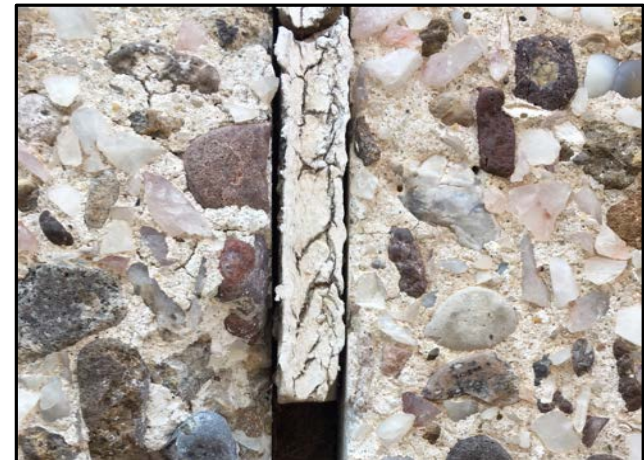
## Example 4: Caulk in Building Facade

- **Project:** Significant multi-year renovation of 8-story building for continued public use.
- **Issue:** 20,000 ppm PCB caulk in concrete facade joints deteriorating with concerns for interior/exterior dust during renovation. The concrete panels cross-contaminated.
- **Solution:** Obtained EPA 761.62(c) risk-based authorization to remove caulk, wire brush and encapsulate affected exposed façade, allowing removal of deteriorating product but maintaining concrete in place for now.

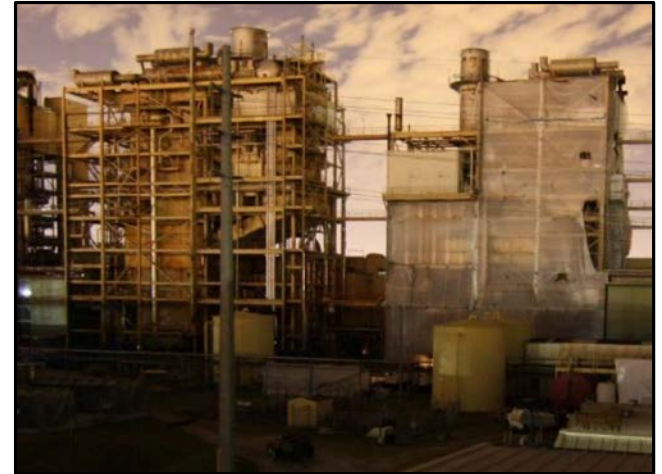
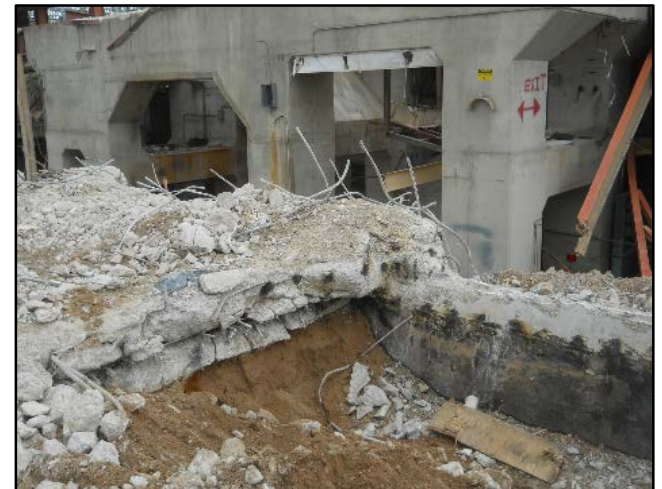
## Example 5: Mastic on Concrete

- **Project:** A 1950s era gas-fired power plant undergoing complete demolition
- **Issue:** Adhesive/mastic with PCB Aroclor 1262 > 50 ppm found on concrete during demolition of plant boiler foundation
- **Solution:** Broke out concrete with mastic for disposal as a PCB bulk product waste under 761.62(b) as no PCB spills known. Remaining concrete closed in place.

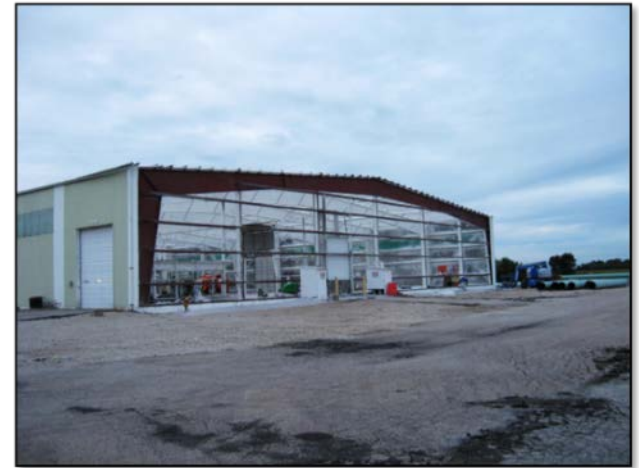
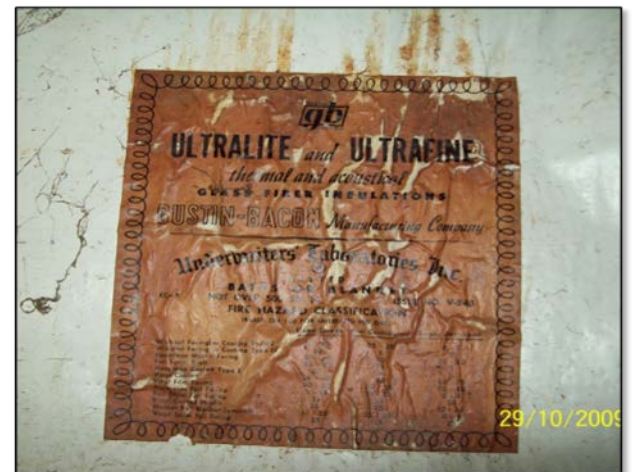
## Example 6: Insulation Adhesive

- **Project:** Initial PCB assessment for spills discovered more widespread PCB presence on non-spill surfaces
- **Issue:** Deteriorating PCB-containing roof insulation with Aroclor 1254 > 50 ppm, depositing dust / debris on building equipment and other painted surfaces
- **Solution:** Partial building dismantlement (“skinning”) to remove deteriorating NLPCB insulation for replacement and more cost effective decontamination.

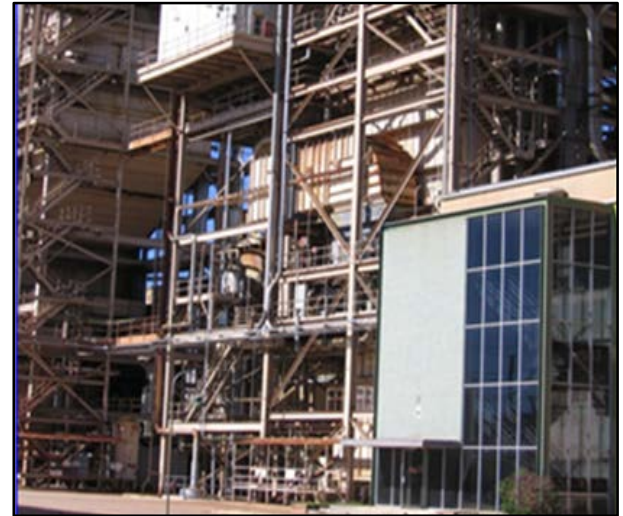
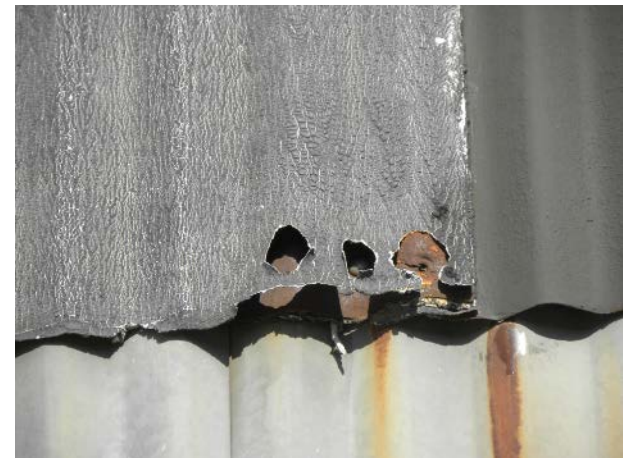
## Example 7: Interior Paneling

- **Project:** An operating 1950s-1960s gas fired power plant with PCB discharge concerns.
- **Issue:** PCB found in plant oil bath led to cleaning of plant ventilation shaft that was not easily cleaned. Deteriorating Galbestos (Aroclor 1268) discovered to be a source.
- **Solution:** Galbestos was removed and disposed of so that shaft and oil bath could be finally cleaned to allow ongoing use.

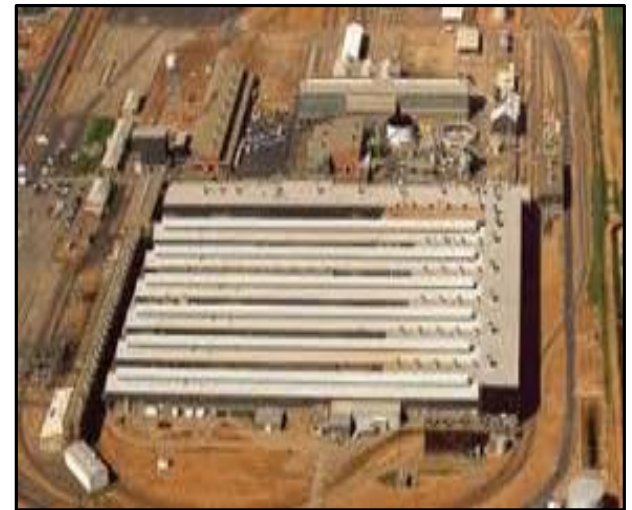
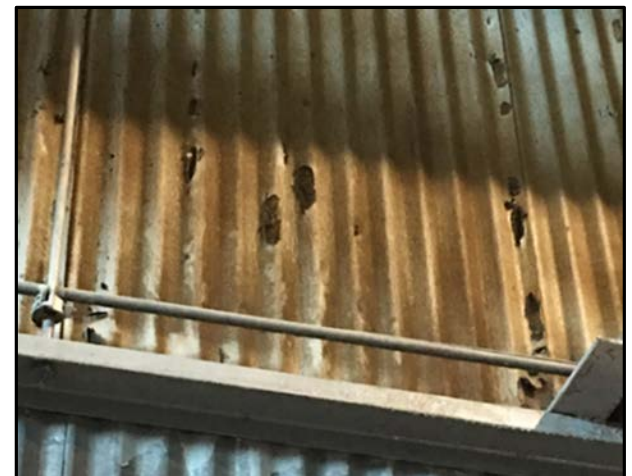
## Example 8: Exterior Building Siding

- **Project:** 700,000 SF aluminum plant built in 1942 being repurposed for industrial use.
- **Issue:** Siding containing 40,000 ppm PCB (Aroclor 1268) in tar coating. Material found to be deteriorating Galbestos thought to be cross-contaminating interior and exterior.
- **Solution:** Removed Galbestos roofing and wall paneling due to its deterioration at significant cost to allow effective decon for long term building revitalization and reuse for new industrial tenants as part of an economic redevelopment initiative.

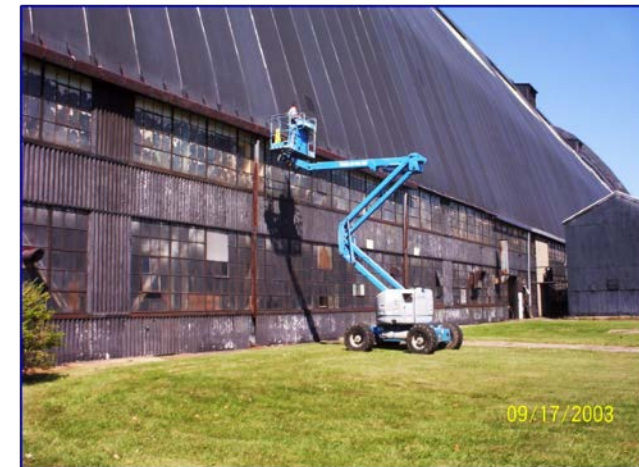
## Example 9: Exterior Building Siding

- **Project:** Cleanup of a large hangar built in 1929 for air ship (i.e., blimp) construction
- **Issue:** Roofing/siding was Galbestos with 40,000 ppm PCB in tar coating found to be deteriorating and causing detected cross-contamination of interior surfaces.
- **Solution:** Avoided expensive removal by cleaning equipment, coating floors, and removing affected soil/concrete, with EPA “Consent Agreement & Final Order” to enable ongoing use with air monitoring.
