Solving PCB Impediments to Decommissioning

Stephen Mitchell, PG Senior Vice President Weston Solutions, Inc. J.D. Groesbeck, PG Project Manager Weston Solutions, Inc.

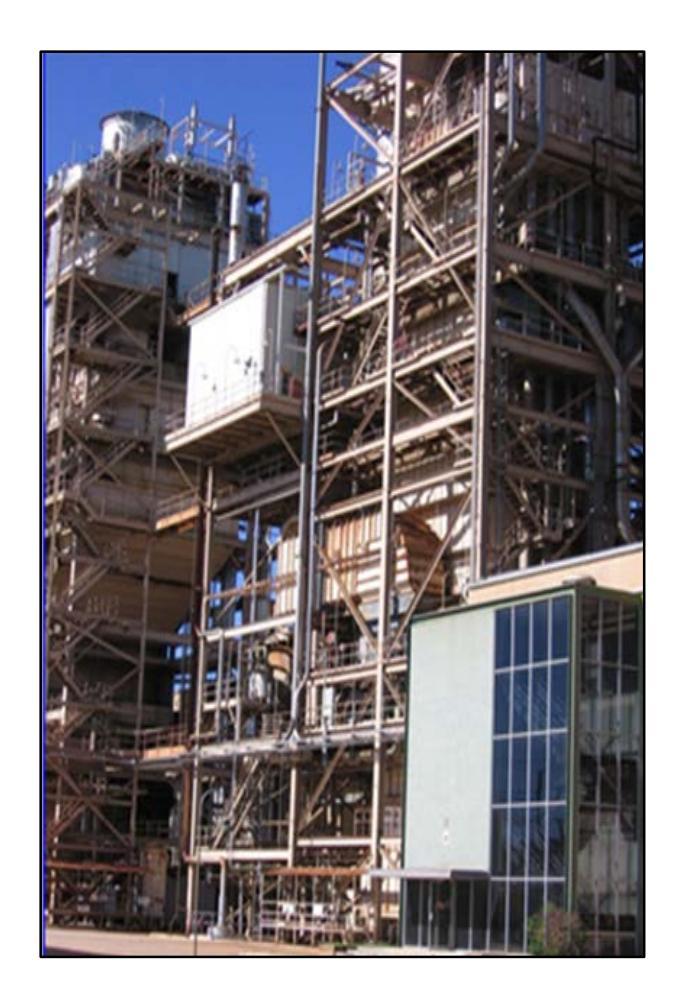
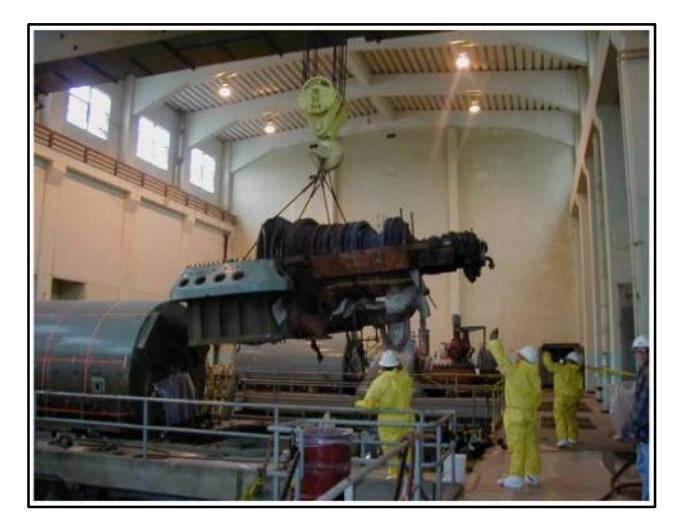
PCB in Oil-Filled Equipment

- Scenario: Plant oil-filled transformers, capacitors, regulators, and breakers had to be managed during demolition.
- **Options**: Continued use per 761.30 authorizations or disposal per 761.60.
- Solution: Included equipment inventory and handling instructions in bid specs.
- Result: Contractor drained free flowing oil and decontaminated equipment for recycling/disposal without incident.
